**Customer:** Ceiling Tile Manufacturer  
**Location:** Marietta, PA  
**Specialist:** David Hungarter  
**Flooring System:** Milamar Coatings  
**Date Installed:** December, 2017

*A leading ceiling tile manufacturer had a series of recently constructed concrete trenches used for draining water based latex paint expelled in their production process.*

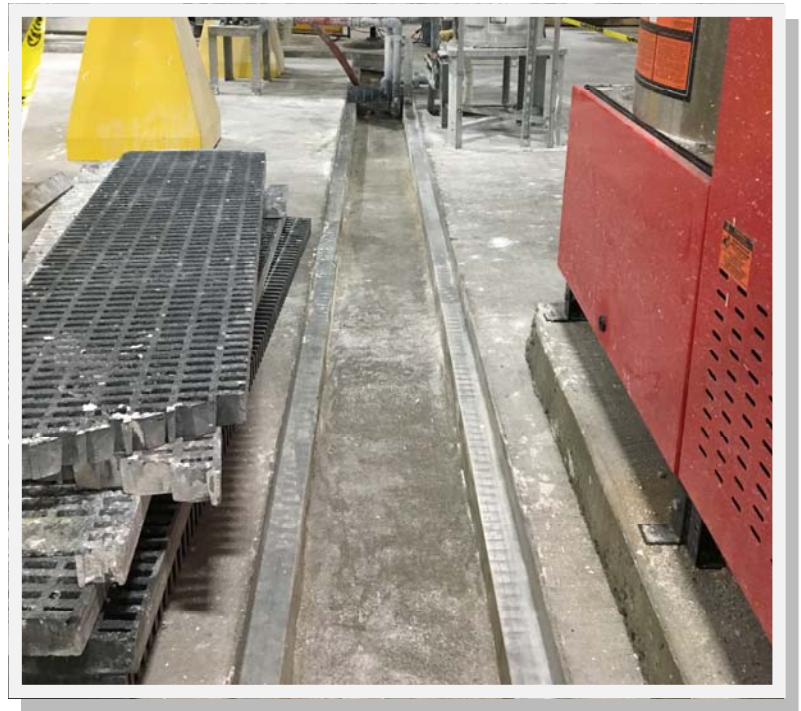
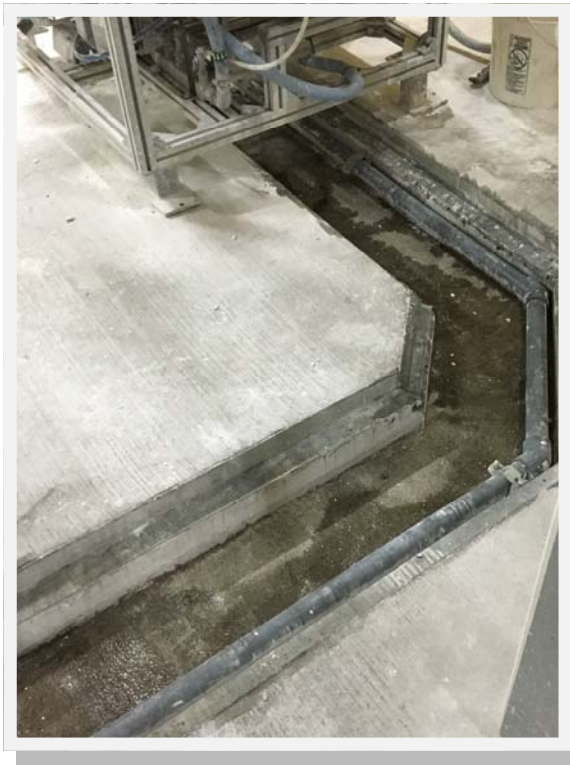
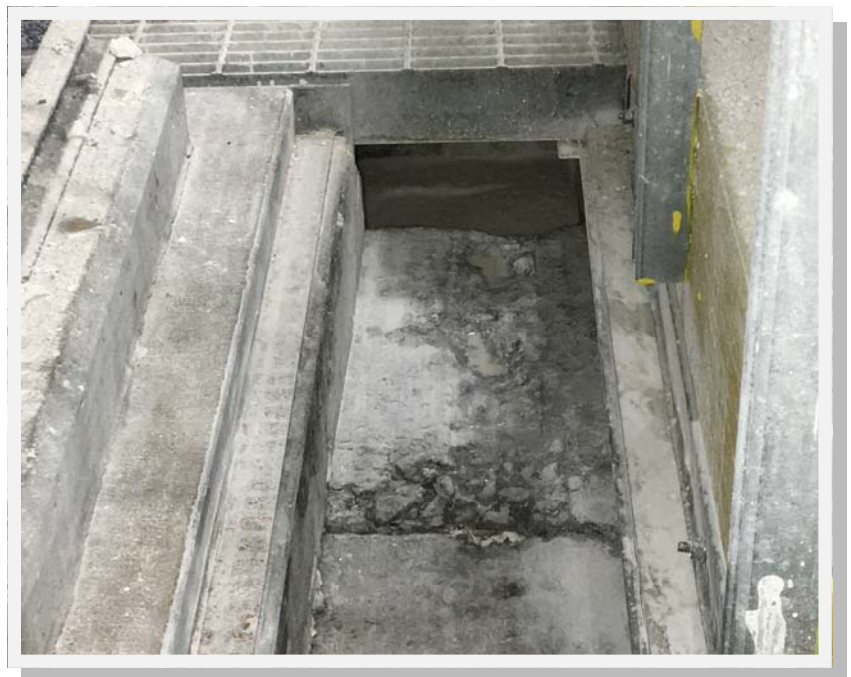
*Unsatisfactory construction resulted in the trenches having high spots as well as cracks that impeded flow and made cleaning difficult.*

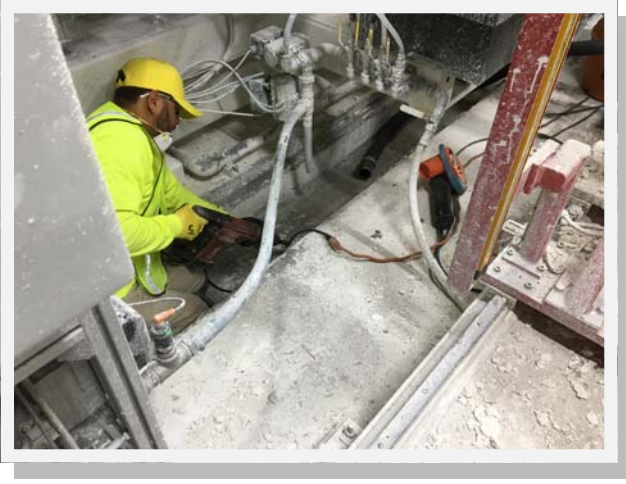
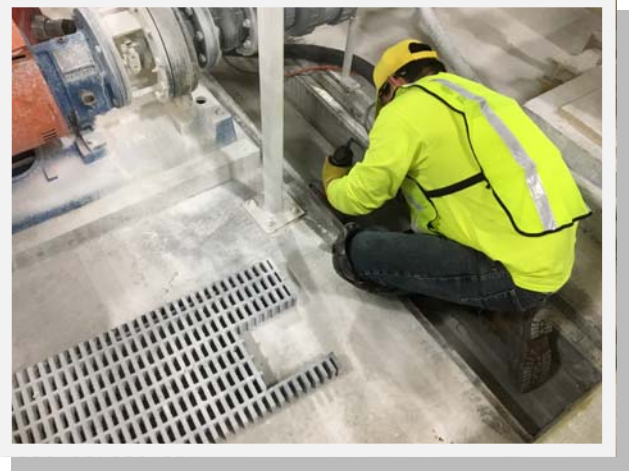
*Surface preparation is key to ensuring an excellent finished result, and CPE doesn't cut corners.*

*CPE chipped away built up concrete and filled large cracks and holes. All surfaces to be coated were ground to create a proper profile for best product adhesion.*

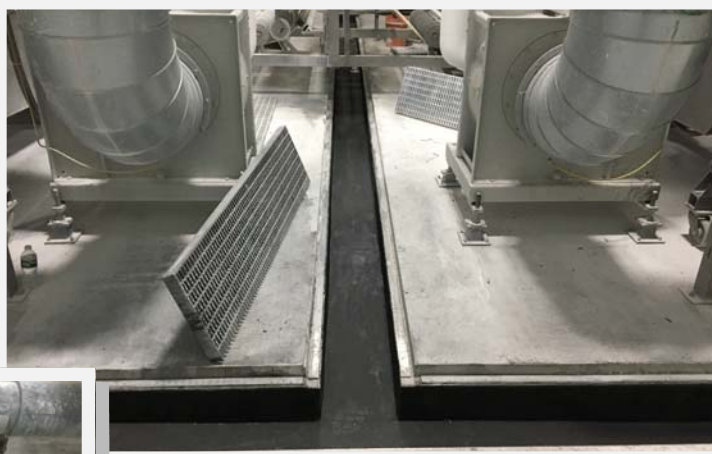
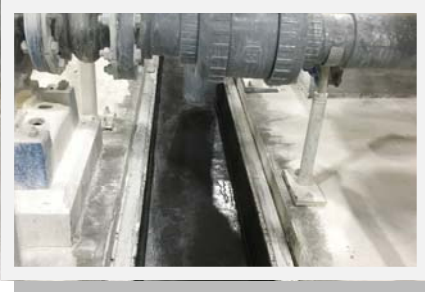
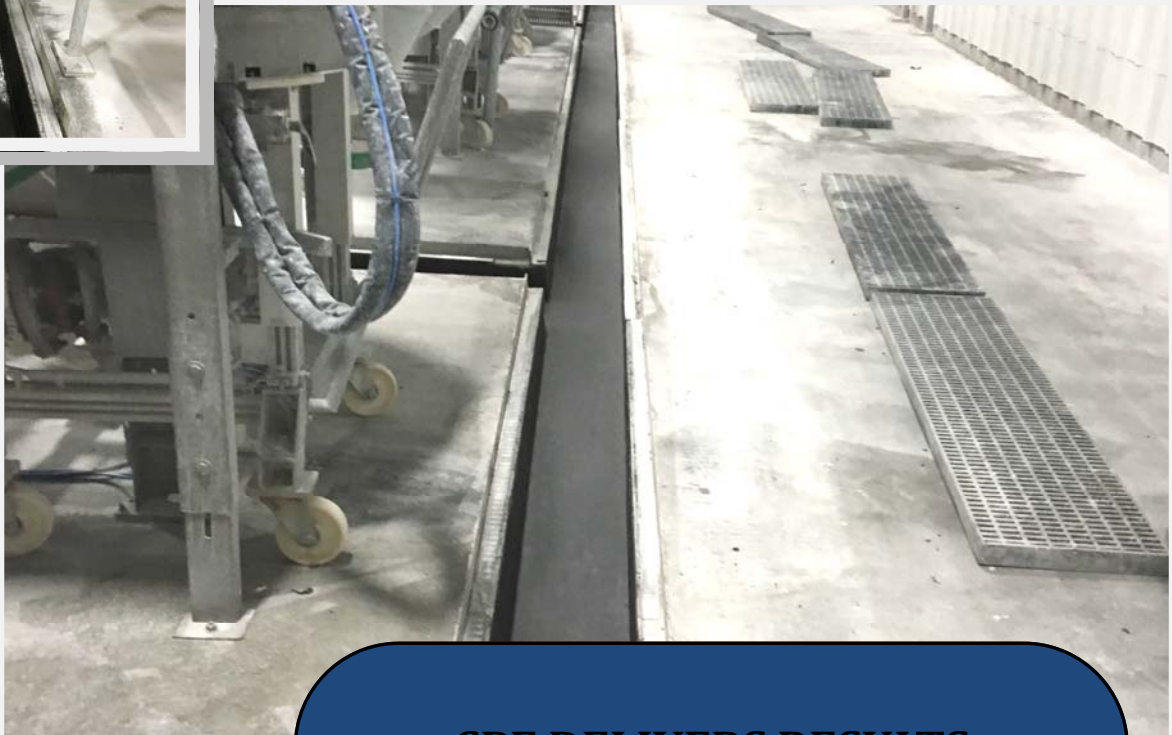
*The finished trenches have improved flow of the latex paint waste and have made the cleaning process much easier for our client's workers.*
