SERVICE SYSTEMS SOLUTIONS

Customer: Brewery

Location: Breinigsville, Pennsylvania

Flooring System: Milamar Coatings, L.L.C.: ICO

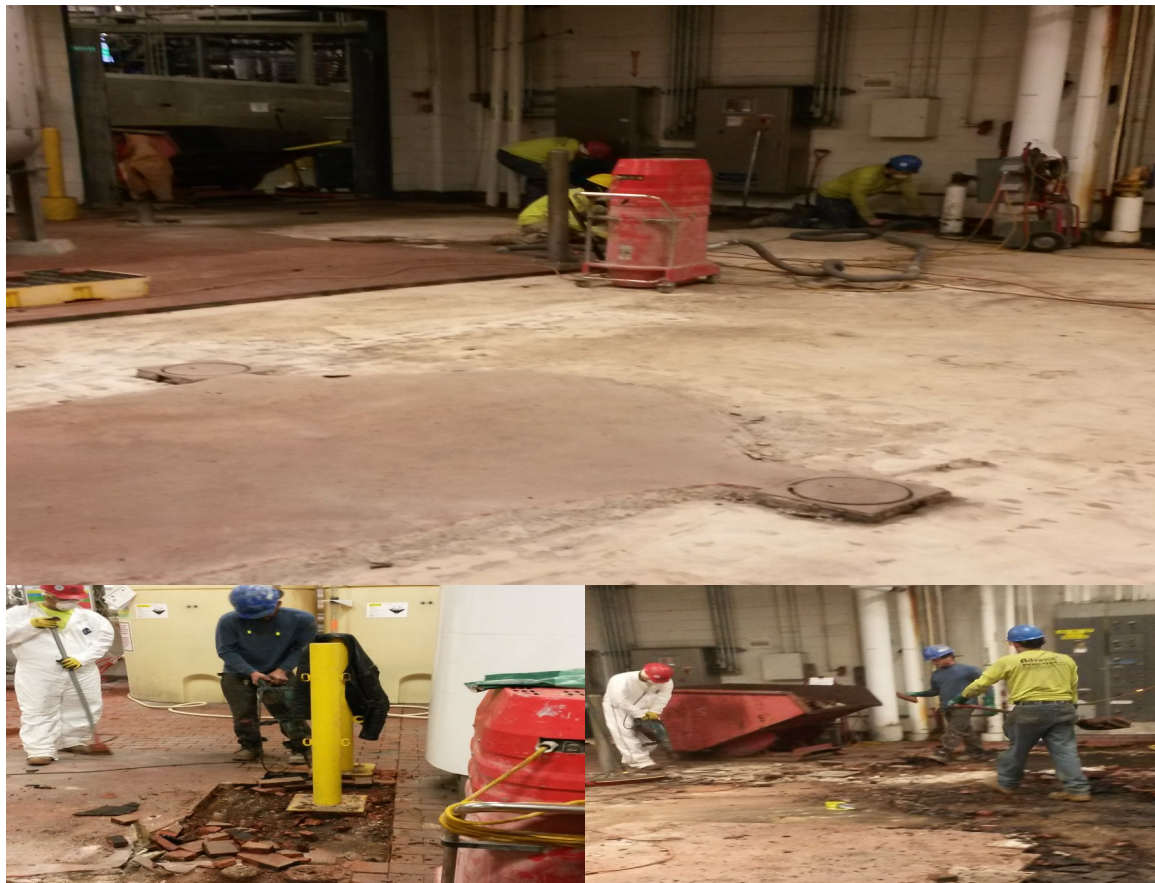
*Customer had an aging acid brick floor in a chemical tank storage room which had become damaged from fork-truck traffic and was no longer offering suitable chemical resistance.*

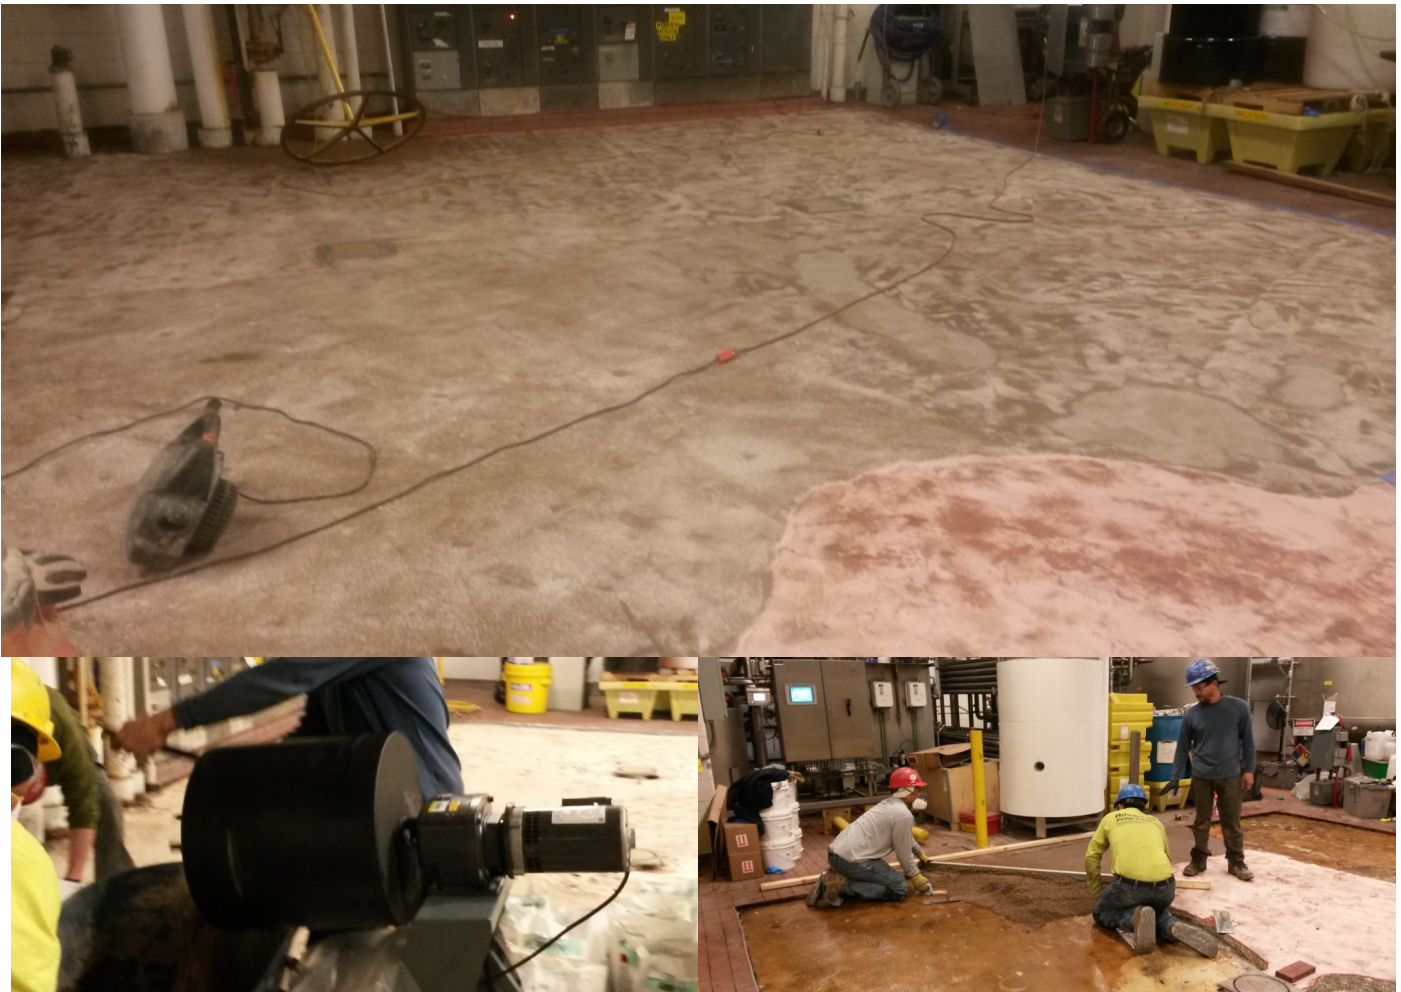
### ***REMOVAL OF OLD FLOOR***

Demolition and removal of old acid brick flooring which was damaged from fork-truck traffic and chemicals that seeped through worn grout lines and cracks.

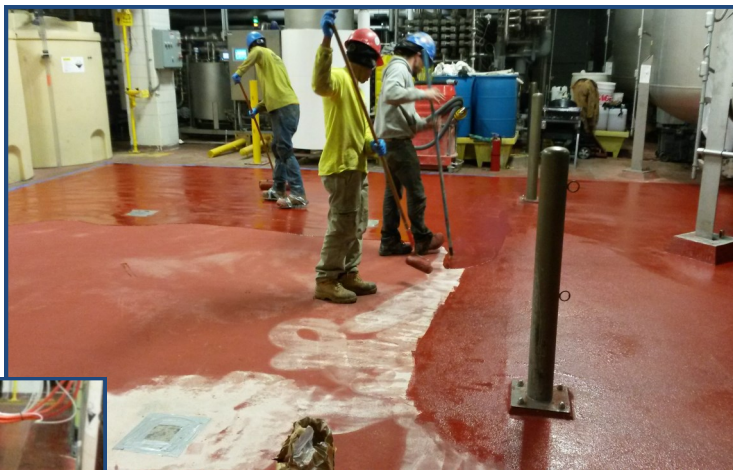
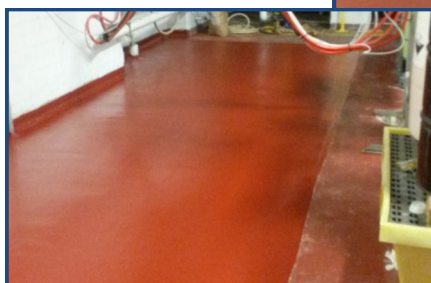
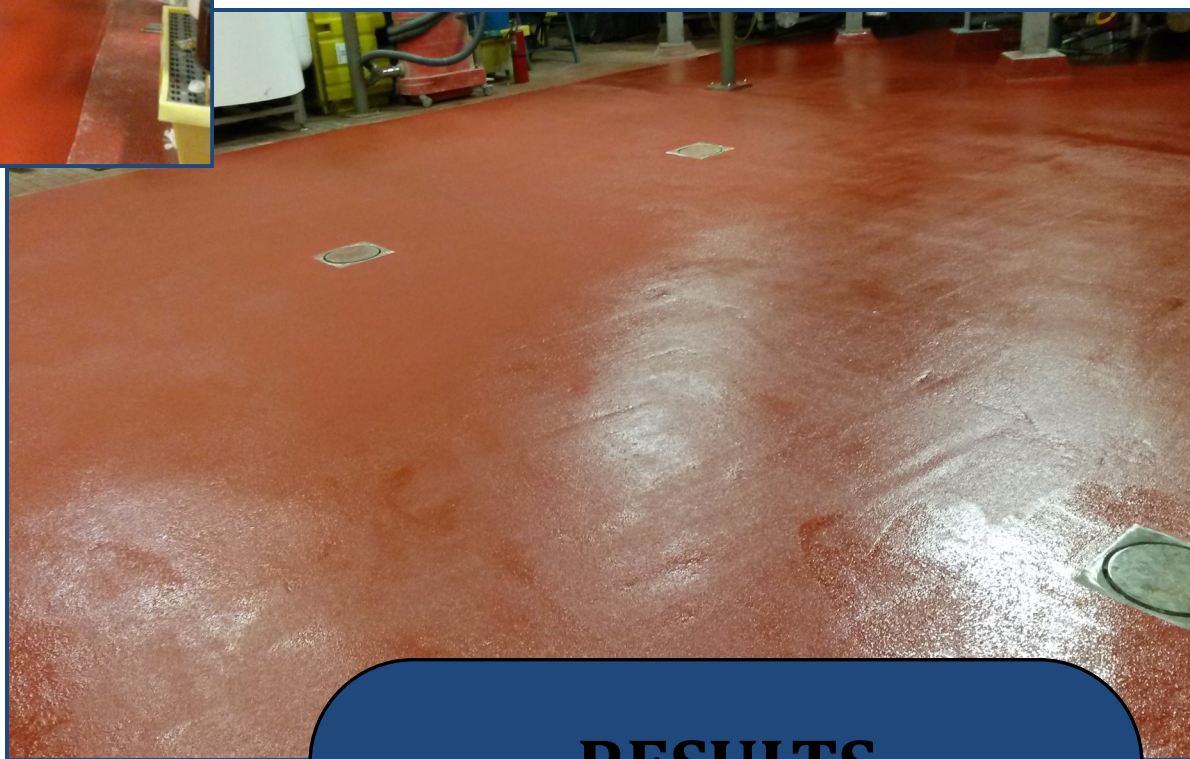
## RESULTS

The finished floor provides greater structural support to withstand fork-truck traffic, is protected from chemical attacks, and offers improved slip resistance.

The new surface looks great, is easier to clean and maintain, and will continue to provide satisfaction for years to come.

Forming a new flooring surface with Milamar ICO URE Guard Slurry . This new surface offers 4 times the compression strength and greatly increased chemical resistance than that of the old acid brick surface. It will stand up to the fork-truck traffic without cracking and protect against chemical spills.
